ROSS ENVIRONMENTAL ASSOCIATES, INC.

10 October 2013

RE: *UST Closure – Jay Peak Ski Resort, Stateside Garage (Facility # 2622)
217 Stateside Road – Jay, Vermont*

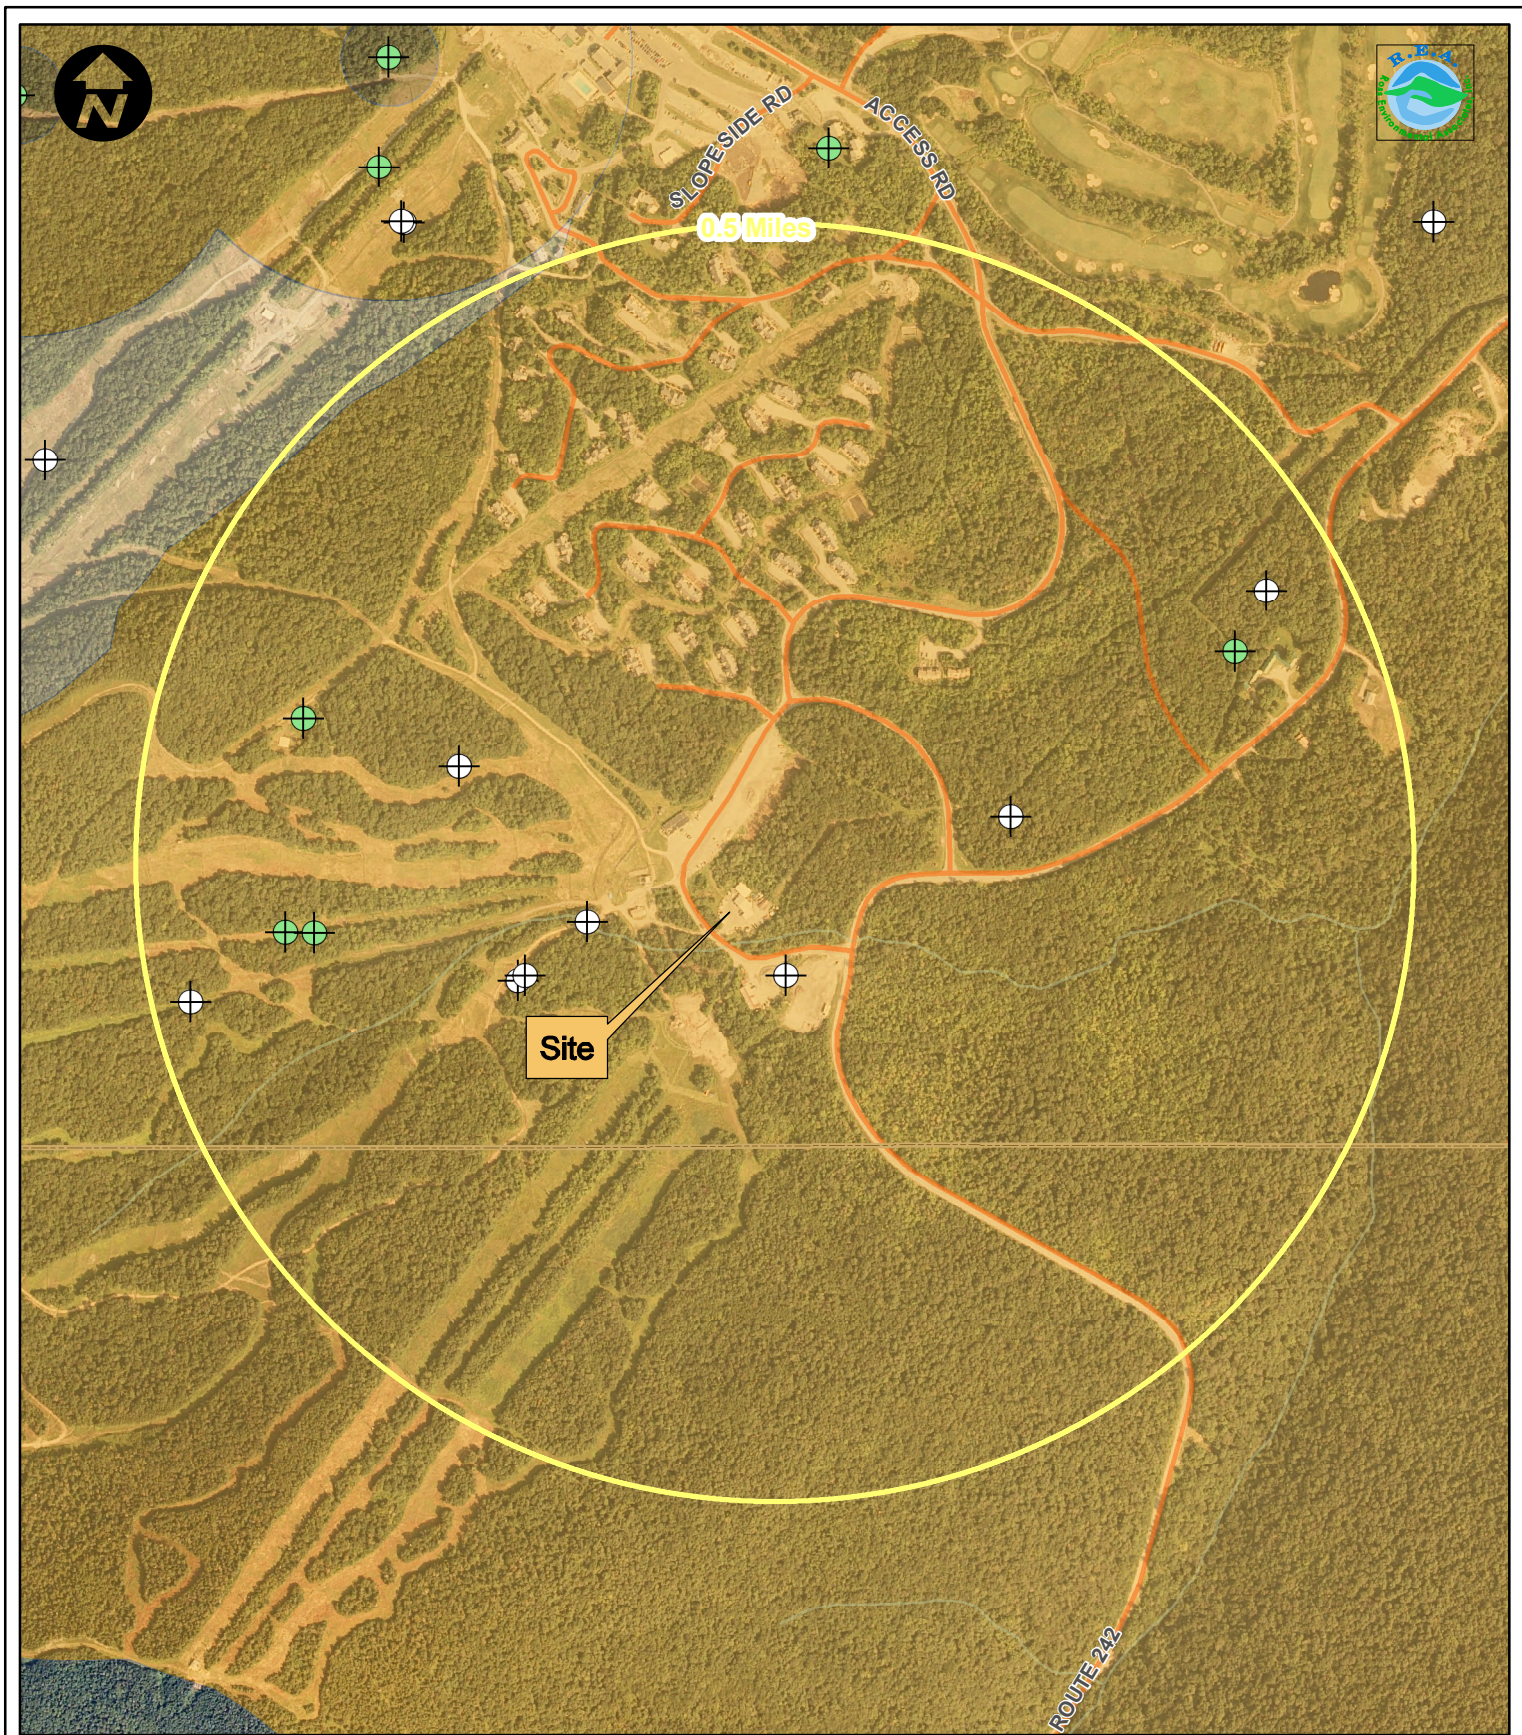
The nearest surface water body to the former UST system is the Jay Branch tributary of the Missisquoi River, which is located approximately 200 feet to the southeast. The approximate locations of nearby sensitive receptors are shown on **Figure 2**.

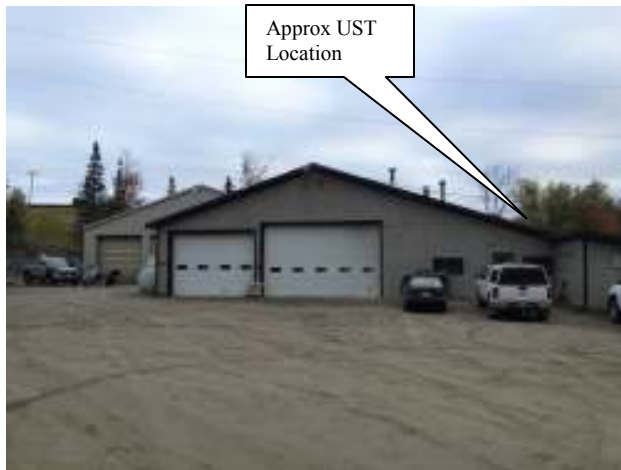
Photograph 1. Overview of Site and UST Location - View toward North.

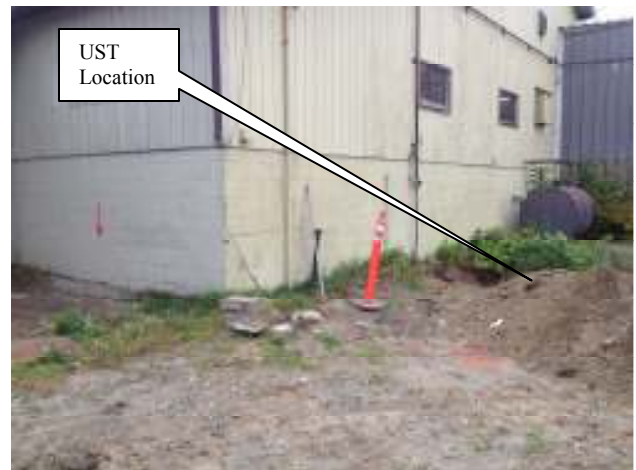
Photograph 2. View of UST location, prior to removal - View toward Southwest.

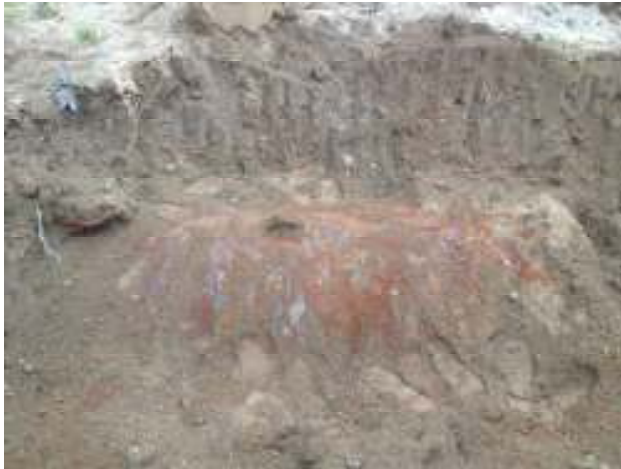
Photograph 3. View of top of tank at exposure - View toward West.

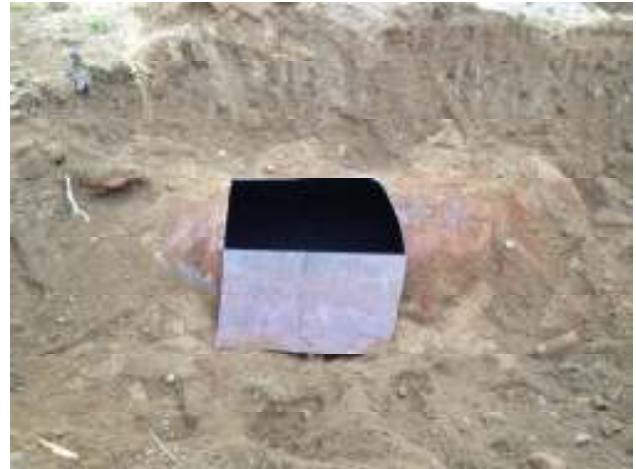
The 1,000-gallon, single-walled steel UST was likely installed approximately 50 years ago, according to Jay Peak Maintenance personnel. Approximately 800 gallons of waste fuel, water and tank bottom sludge were removed from the UST prior to removal, and placed into a PE holding container for subsequent proper disposal by Jay Peak Resort. The tank was found to be in poor condition upon removal with rust, pitting, and several observable holes. The tank was cut and cleaned by FPH Tank Installation and Services of Orleans, Vermont. The tank will be disposed of as scrap metal at All Metals Recycling of Hardwick, Vermont.

Photograph 4. View of UST after cutting and cleaning - View toward West.

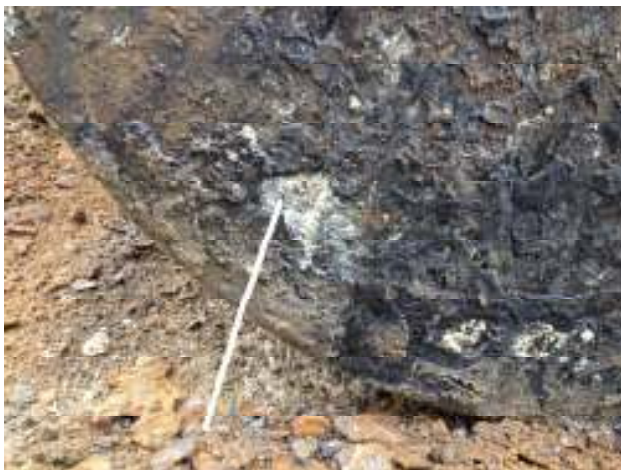
- The 1,000-gallon UST is believed to have been installed approximately 50 years ago. The tank was found to be in poor condition upon removal with rust, pitting, and several holes observed on endwall and sidewalls.

- Photo-ionization detector (PID) readings on soils from the excavation ranged from 0.0 to 220 parts per million-volume (ppmv), which are above the VT DEC action level of 10 ppmv for fuel oil/diesel contaminated soils. The highest PID readings came from the soil around the bottom and lower half of the tank, in proximity to several holes observed in the tank.

Based on visual inspection of the UST and observations of subsurface conditions during the UST closure assessment, the former UST system appears to have released heating fuel into the subsurface environment. The cause of the release is likely due to the poor tank conditions and holes observed in the bottom and lower half of the tank. At the time the degree and extent of contamination has not been determined. Based on the findings of this assessment **R.E.A** recommends the following:

Photograph 5. View of one of several holes in tank - View of Endwall.

- The VT DEC should be notified of the petroleum contamination identified during the UST closure.
- An initial site investigation (ISI) should be completed in order to determine the degree and extent of petroleum contamination at the Site, which should include: sampling and analysis of the on-site drinking water supply, installation of soil borings with the possible installation of monitoring wells, appropriate sampling, and an evaluation of possible impacts to nearby sensitive receptors. The need for additional work should be based on the findings of the ISI.

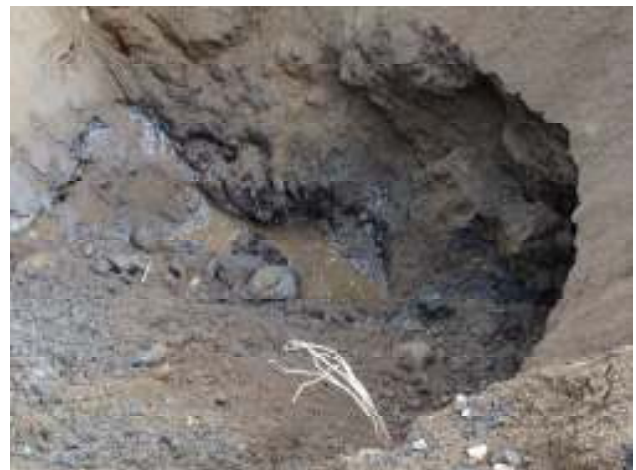
- PID readings inside the garage ranged from 0.0 to 2.0 parts-per-million (ppm), but are likely due to truck cleaning and maintenance products.
- Groundwater was encountered during the excavation at approximately 6.5 feet bgs, and was in direct contact with petroleum contaminated soils (PCS).

Soils in the excavation consisted of brown sands with gravel from ground surface to the bottom of excavation at approximately 6.5 feet bgs. Groundwater was observed at approximately 6.5 feet bgs. PID readings on the soils from the UST excavation ranged from 0.0 to 220 ppmv, which is above the VT DEC action level of 10 ppmv for fuel oil/diesel contaminated soils. A drainage pipe was discovered in the

Photograph 6. View of excavation bottom after tank removal, note groundwater - View toward South.
